# Selling Arguments *for* TIN ROOFING

*A review of the advantages of  
roofs of this type*

A textbook containing corrected tables for use in estimating, instructions for laying tin roofs, description of the manufacture of roofing tin, and a large amount of information useful to the practical man.

N. & G. Taylor Company, Philadelphia

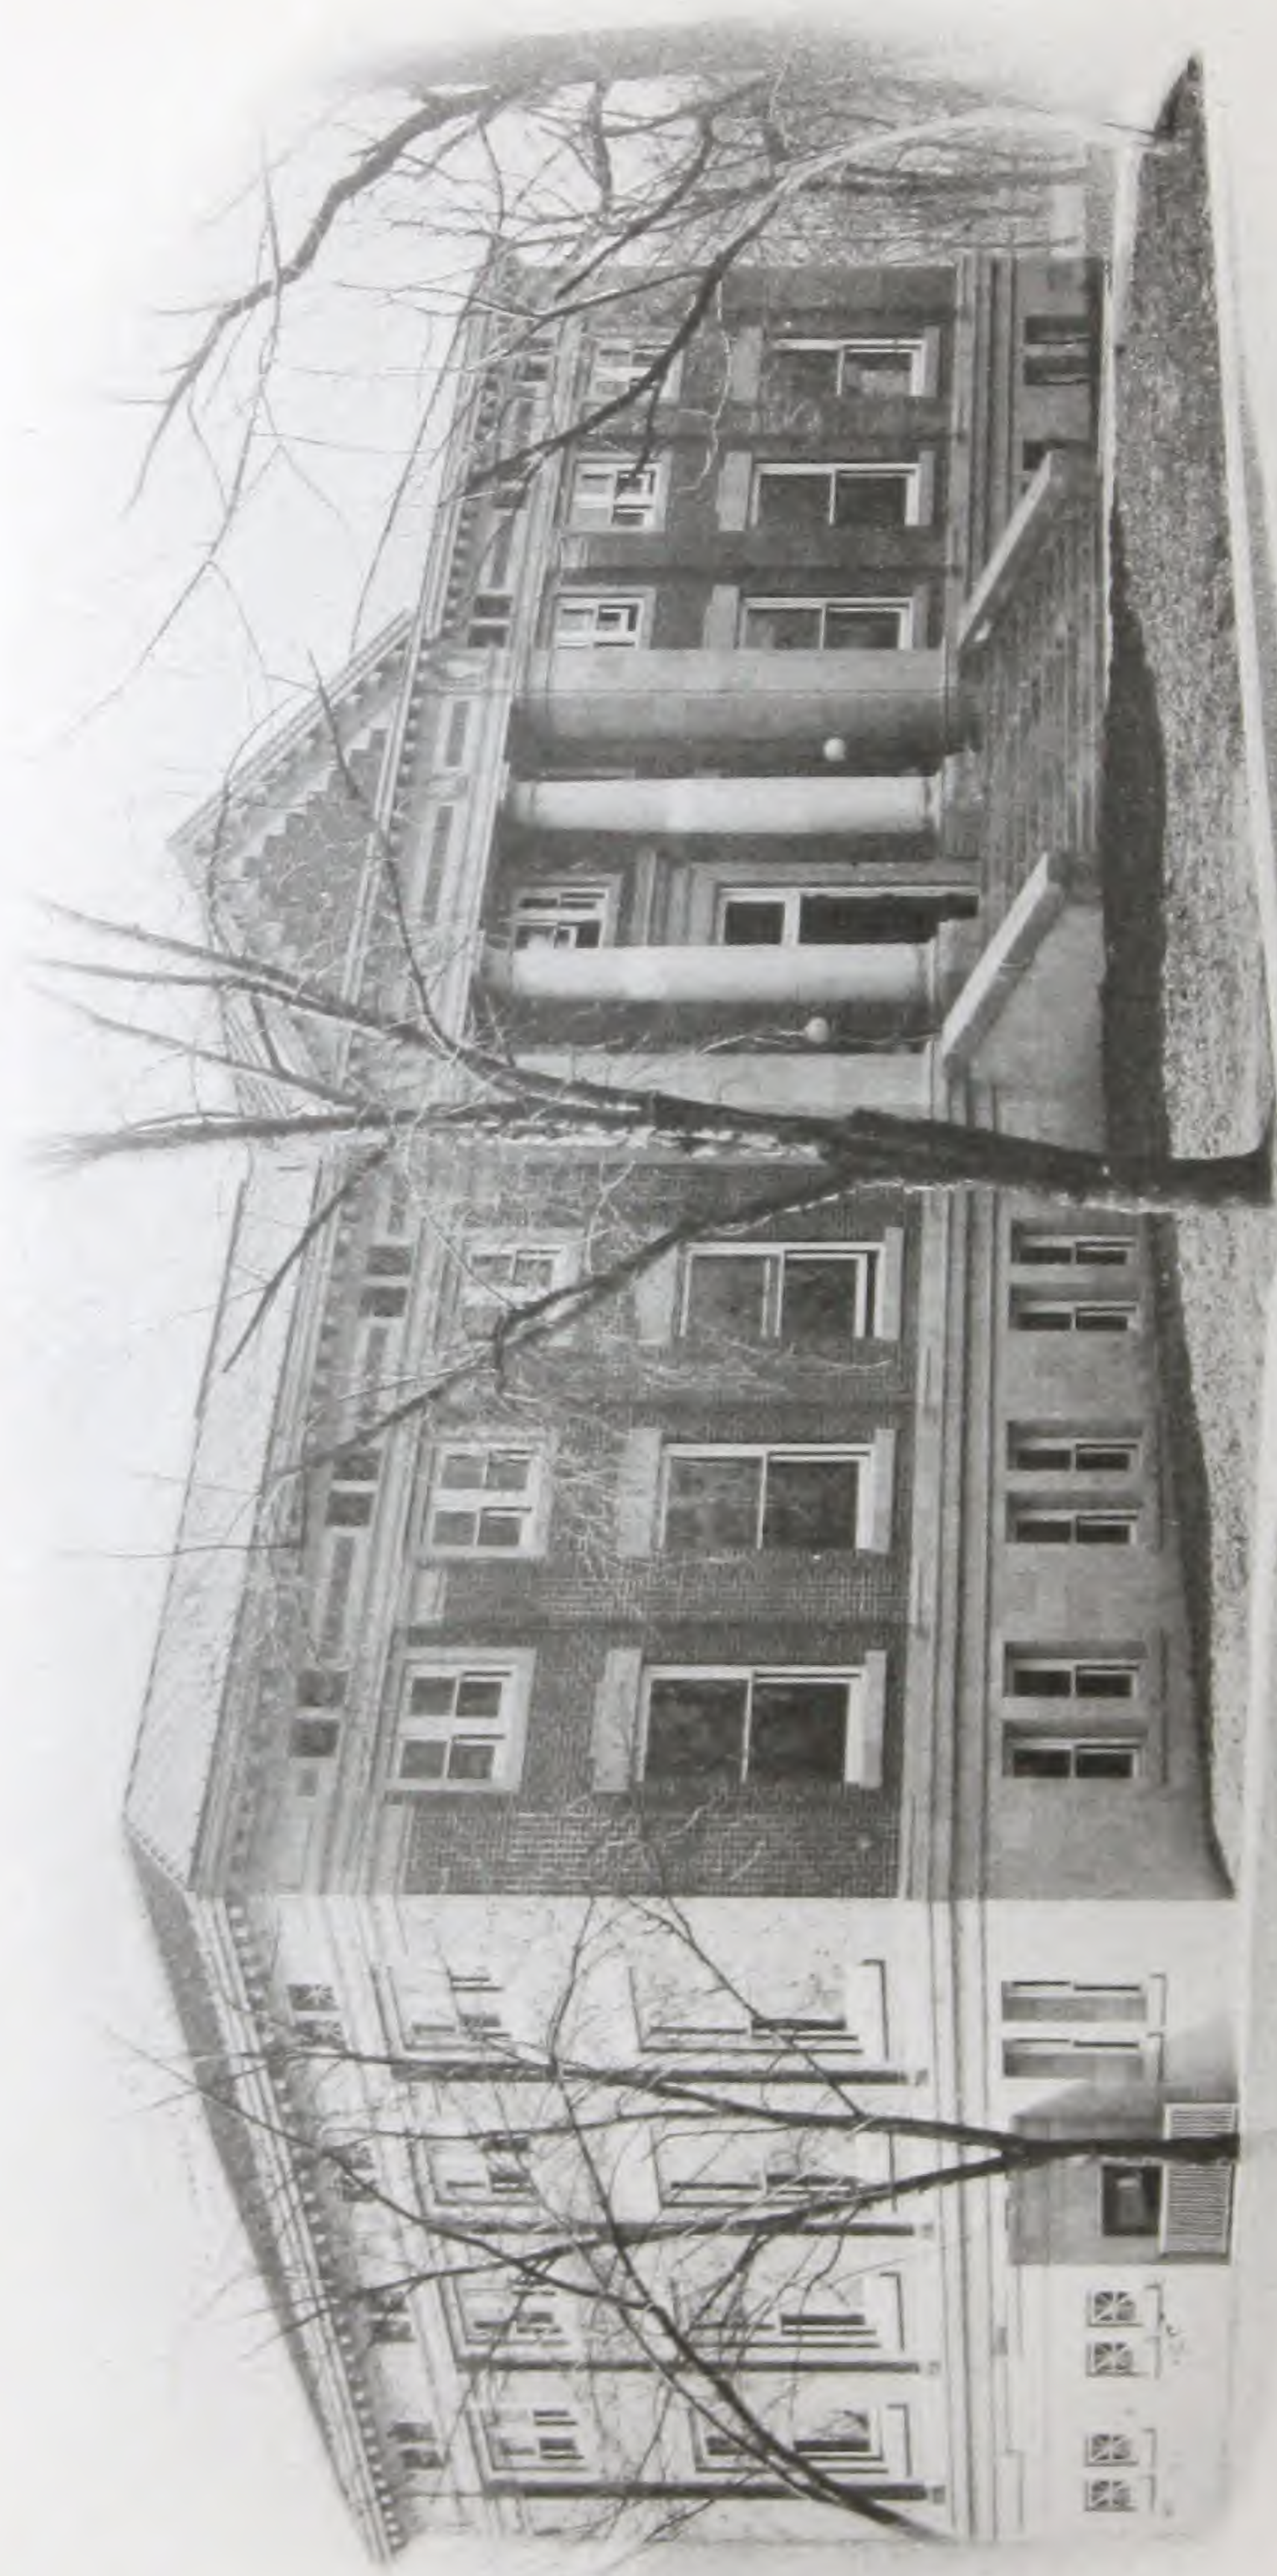
CARNEGIE LIBRARY, HOWARD UNIVERSITY, WASHINGTON, D. C.

Covered with 7500 square feet of IX Target-and-Arrow roofing tin.

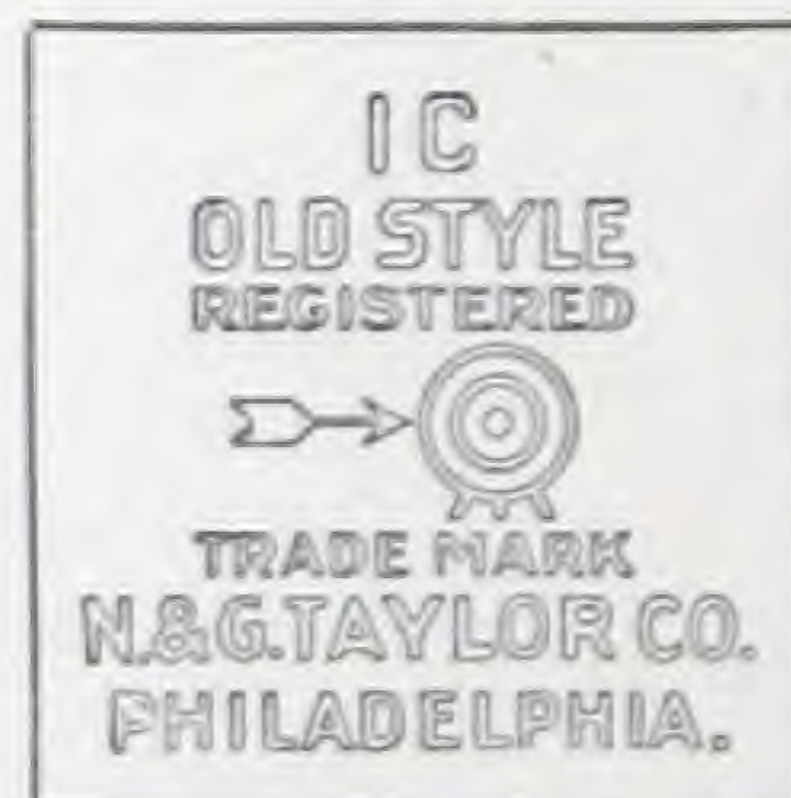
Fac-simile of trade-mark embossed on each sheet  
Registered in the U. S. Patent Office
